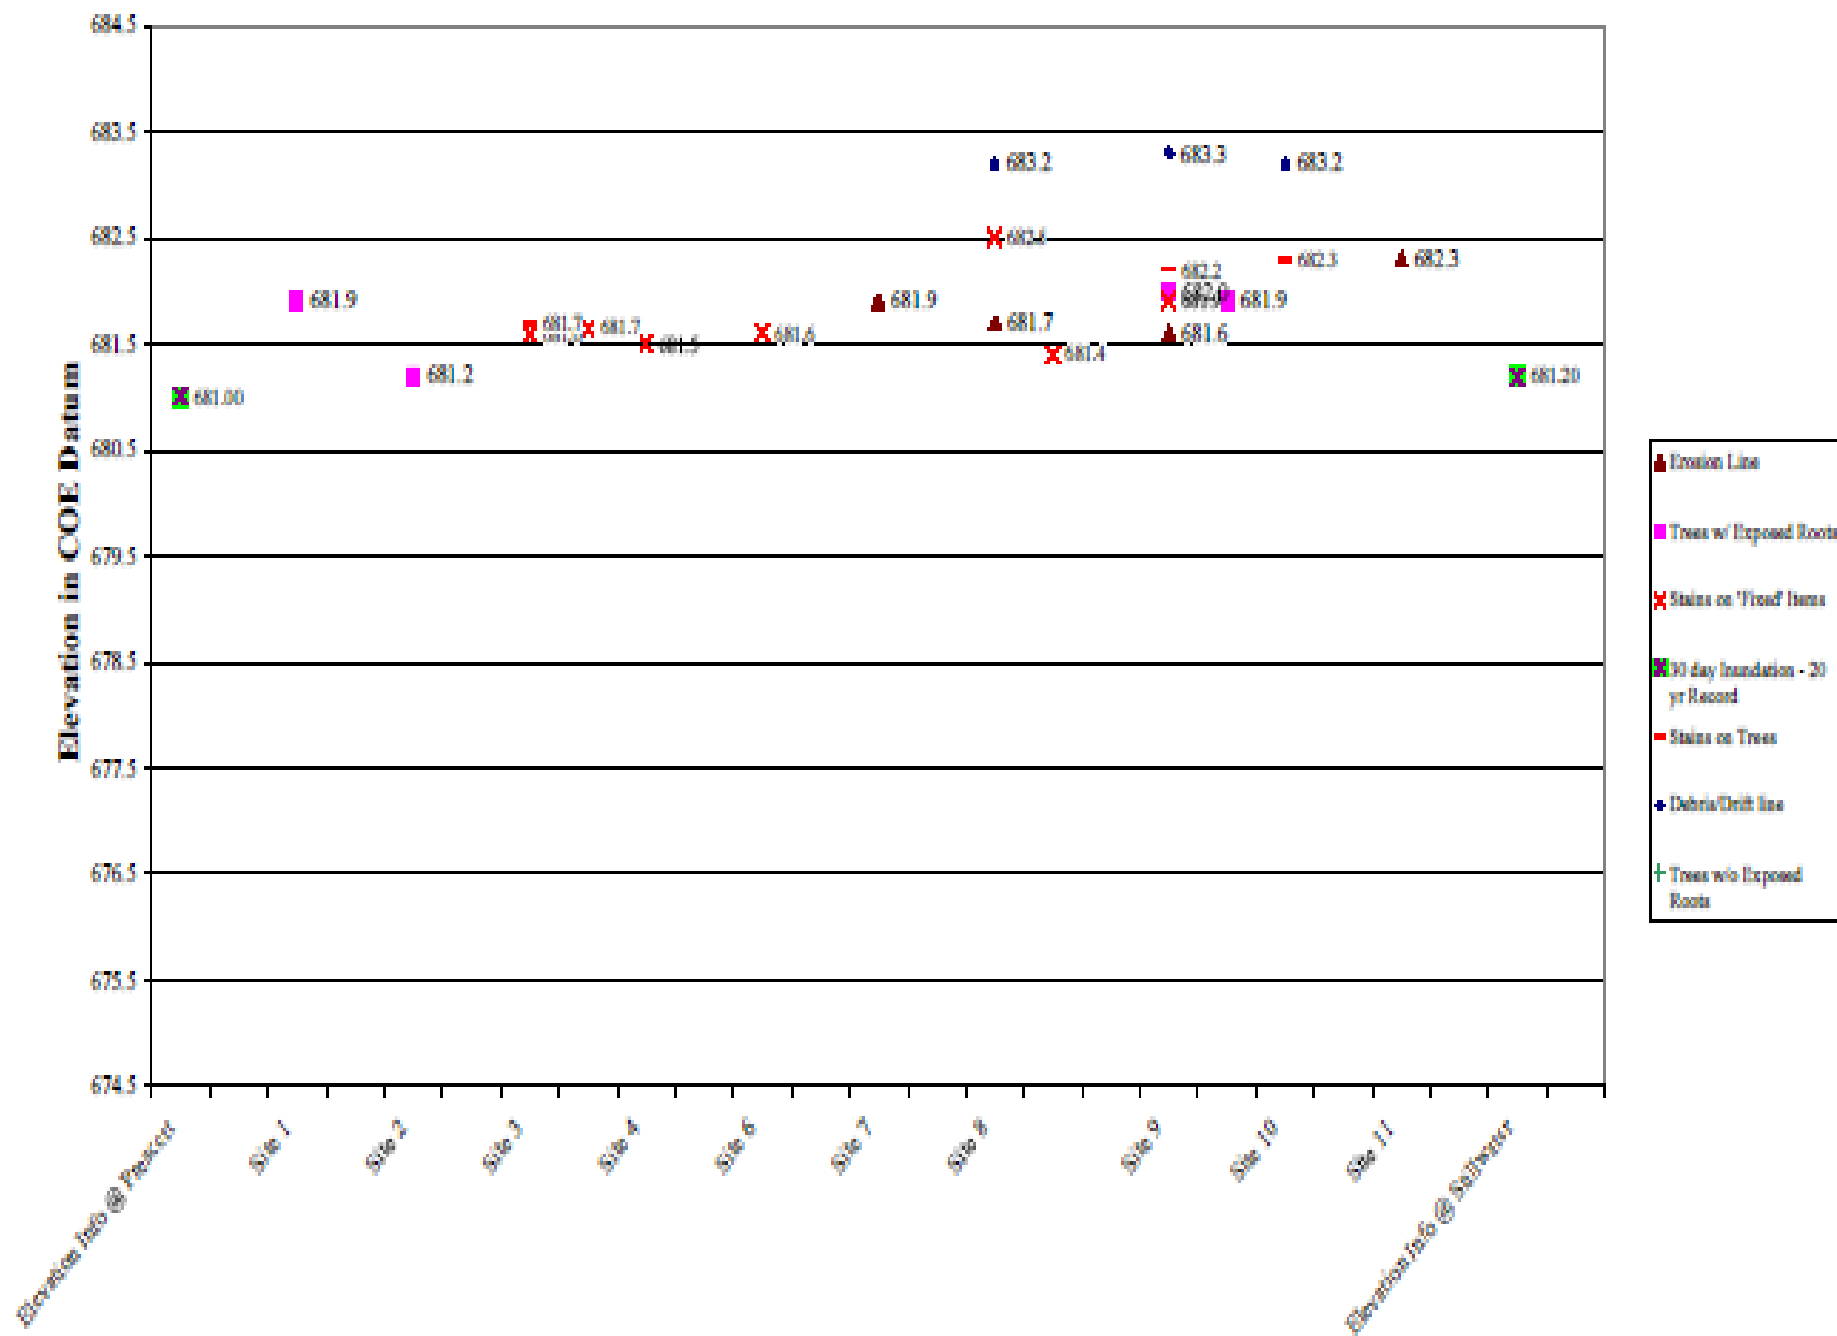
# Predominate Indicator Elevations @ Sites

1. The railroad causeway north of Hudson is a man-made constriction and has an impact on the flow of water through the lake.
2. The recommended OHWM upstream of the Railroad Causeway 681.9.
3. The recommended OHWM downstream of the Railroad Causeway is 681.6.

The most dominant indicators used in the recommendation upstream were the exposed horizontal roots and the stain on the large rock at Site 9.

The most dominant indicators used in the recommendation for downstream were the water stains on the bluff at Site 6 and destruction of vegetation, and rock and tree stains at Site 3.
